EXHIBIT L

SUBJECT: SHERATON INN • S. SAN FRANCISCO

SHERATON INN

MBR JOB #98122

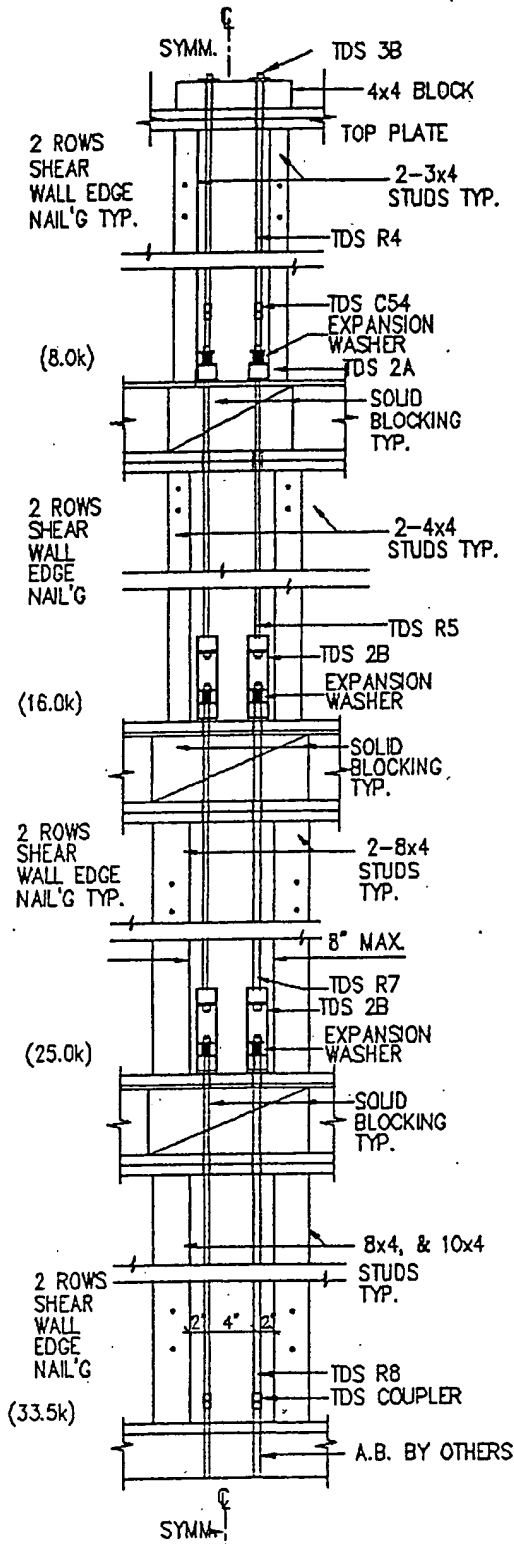
Level 4 (RODS) 10'
 Level 3 (RODS) 163'
 Level 2 (I) 30460 #
 Level 1 (STUDS) 36090 #

3B 2A 2B 2B (4578) 3B 2A 2B 2B (4578)

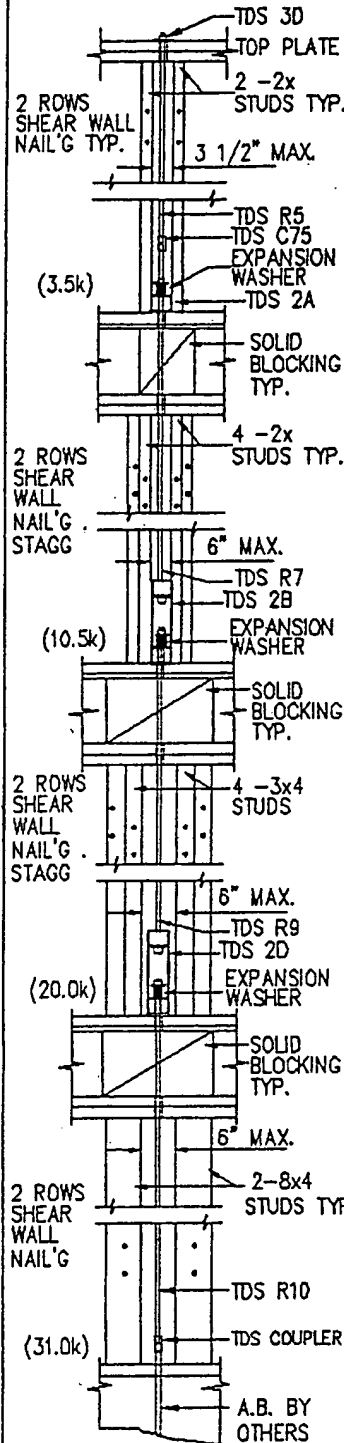
Level 4 (R) 8'
 Level 3 (I) #
 Level 2 (I) 23450 #
 Level 1 (ST) 31710 #

A.B.'S PER STRUCTURAL DWGS.

3D 2A 2D 2D (5,7,9,10)

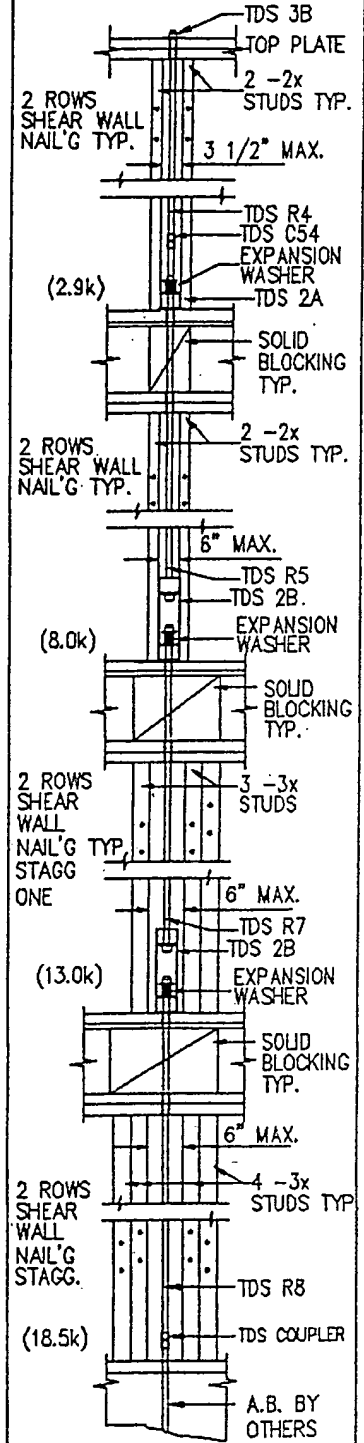
Level 4 (R) 5230 #
 Level 3 (R) 8180 #
 Level 2 (I) 15230 #
 Level 1 (R) 20940 #

A.B.'S PER STRUCTURAL DWGS.

3B 2A 2B 2B (4578)
